A DAM MYSTERY: DEAD RIVER FLOOD

Marquette County, MI
May 14-16, 2003

Information contained herein is from the "Root Cause Report," submitted to UPPCO by the Washington Group, Inc., June 2003.

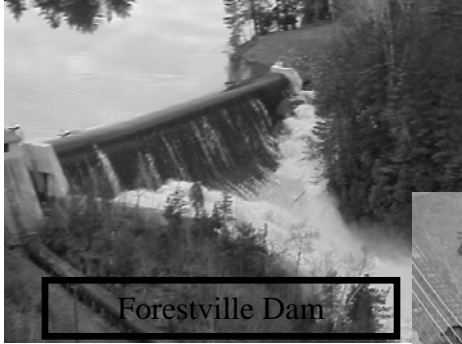
Forestville Dam

- Floodwaters reach Forestville Dam, destroy railroad grade.

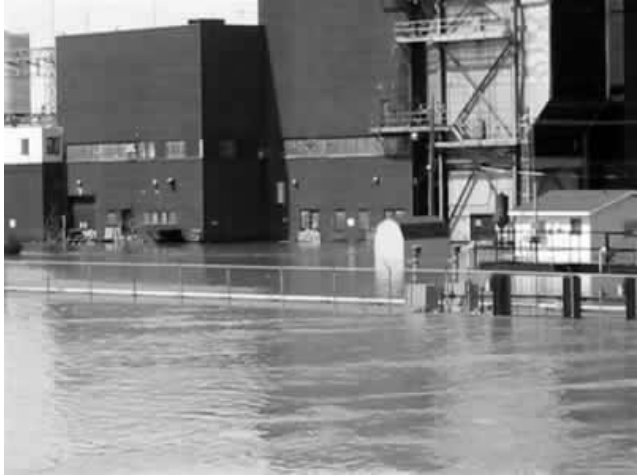
- Considerable damage to Presque Isle Power Plant

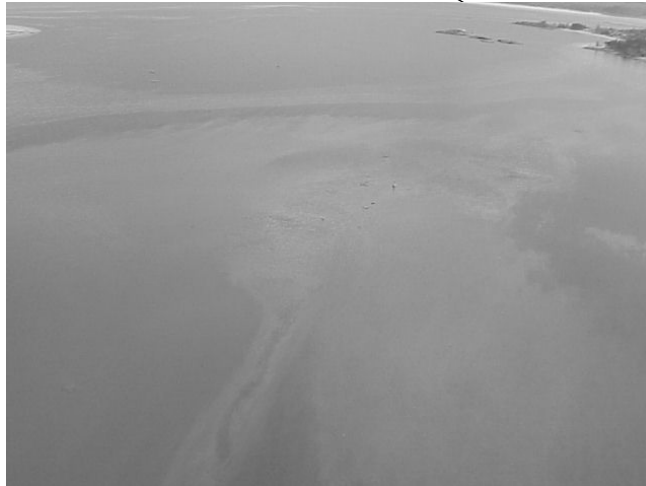
- Silt and debris flow into Lake Superior

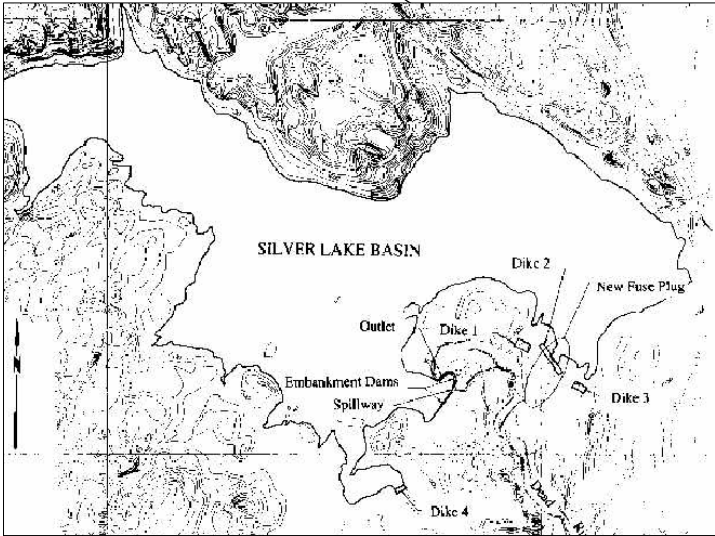
Fuse Plug Dam

- Constructed in Fall 2002.
- Earth dam, about 5 feet high.
- Designed to overtop and serve as an emergency spillway in the event of a very severe flood (approx. 500-yr flood).
- Required operational change – keeping lake level lower to maintain storage capacity for flood control.
