Upper Peninsula Power Company

FERC Project No. 10855
NATDAM Nos. MI00175, MI00183,
and MI00197

Dead River Hydroelectric Project
2013 Annual Report - Operation Monitoring Plan & Report of Deviations Less Than Sixty Minutes

Annual Report

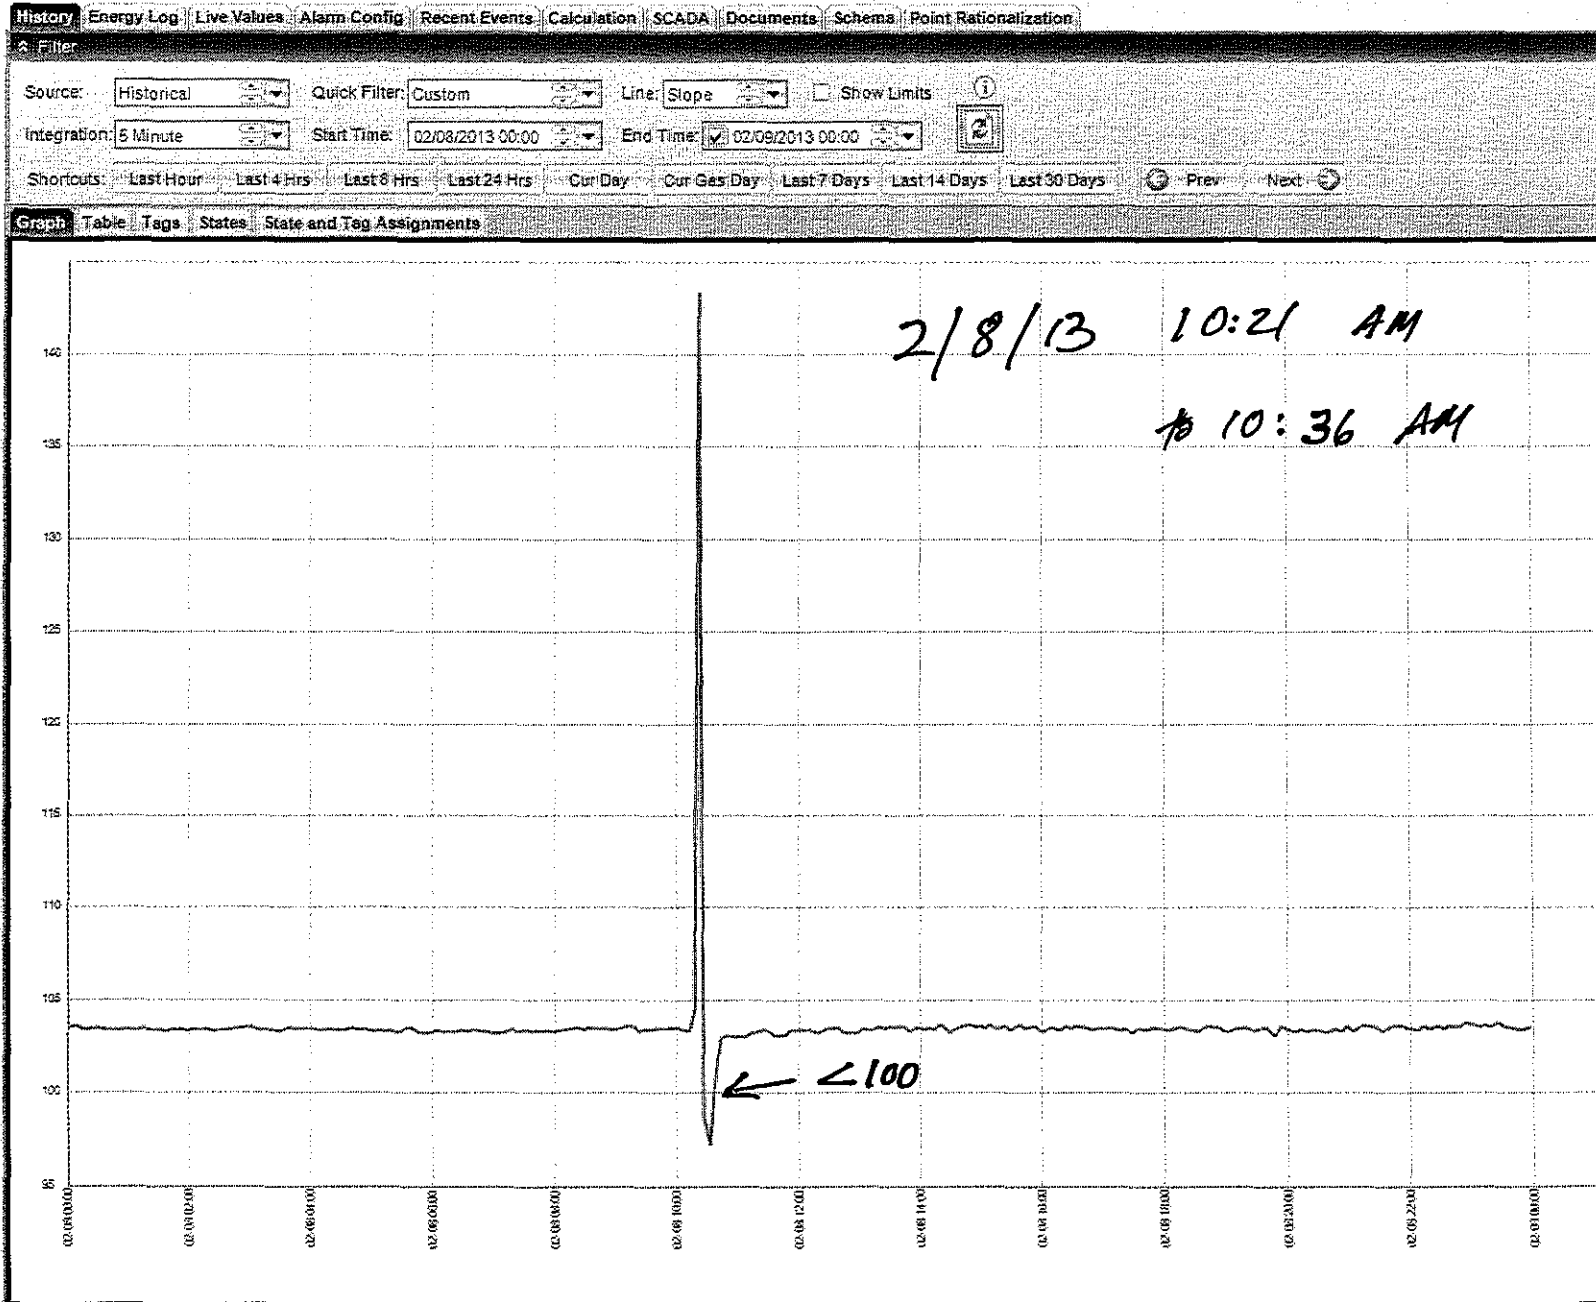
#1

NC Record Number: NCREG4602		Entity: Regional Generation	
Company - Level 1 - Level 2: UPP-Hoist Hydro			
Event Date:	02/08/2013	Discovery Date/Time:	2/8/13 10:26
Event Title: Hoist plant flow <100 cfs during unit swap.			
Event Details: While the local Operator was adjusting flow following swapping of the units, the indicated flow temporarily fell below 100 cfs.			
Immediate Action: Indormed local Operator.			
Recommendations: none			
Potential Causes/Contributors to incident		Possibly the lack of good local flow indication.	
Entered By Name:	Thomas R Grow	Creation Date/Time:	2/8/13 10:50
Entered By Department:	Energy Supply & Control-GenCo	Status:	Closed
Reportable to External Agency:	no	Basis for Reportability:	Not a deviation, flucuation from swapping units
Additional Followup Required:	no		
Category:	Other	Type:	
Sub Type:		Description:	Instrument flucuation
Causal Analysis Level:	Closed - No further action required	Causal Analysis Basis:	Bounce in the reading for flow with two units one, during the a plant unit swap

Event Start:	2/8/2013 10:21 AM	Event End:	2/8/2013 10:36 AM
		Event Duration (HH:MM):	00:15
Evaluator Name:		Evaluator Dept:	
Evaluation Accepted:		Acceptance Comments:	
Eval Due Date:		Eval Completion Date:	
Approver Name:		Corrective Action Approver Name:	
Analysis Description:			
Causes:			
Primary Causes:			
Does Eval Require Sceening Committee Approval upon Completion		no	
Evaluation Reviewed/Approved by Screening Committee

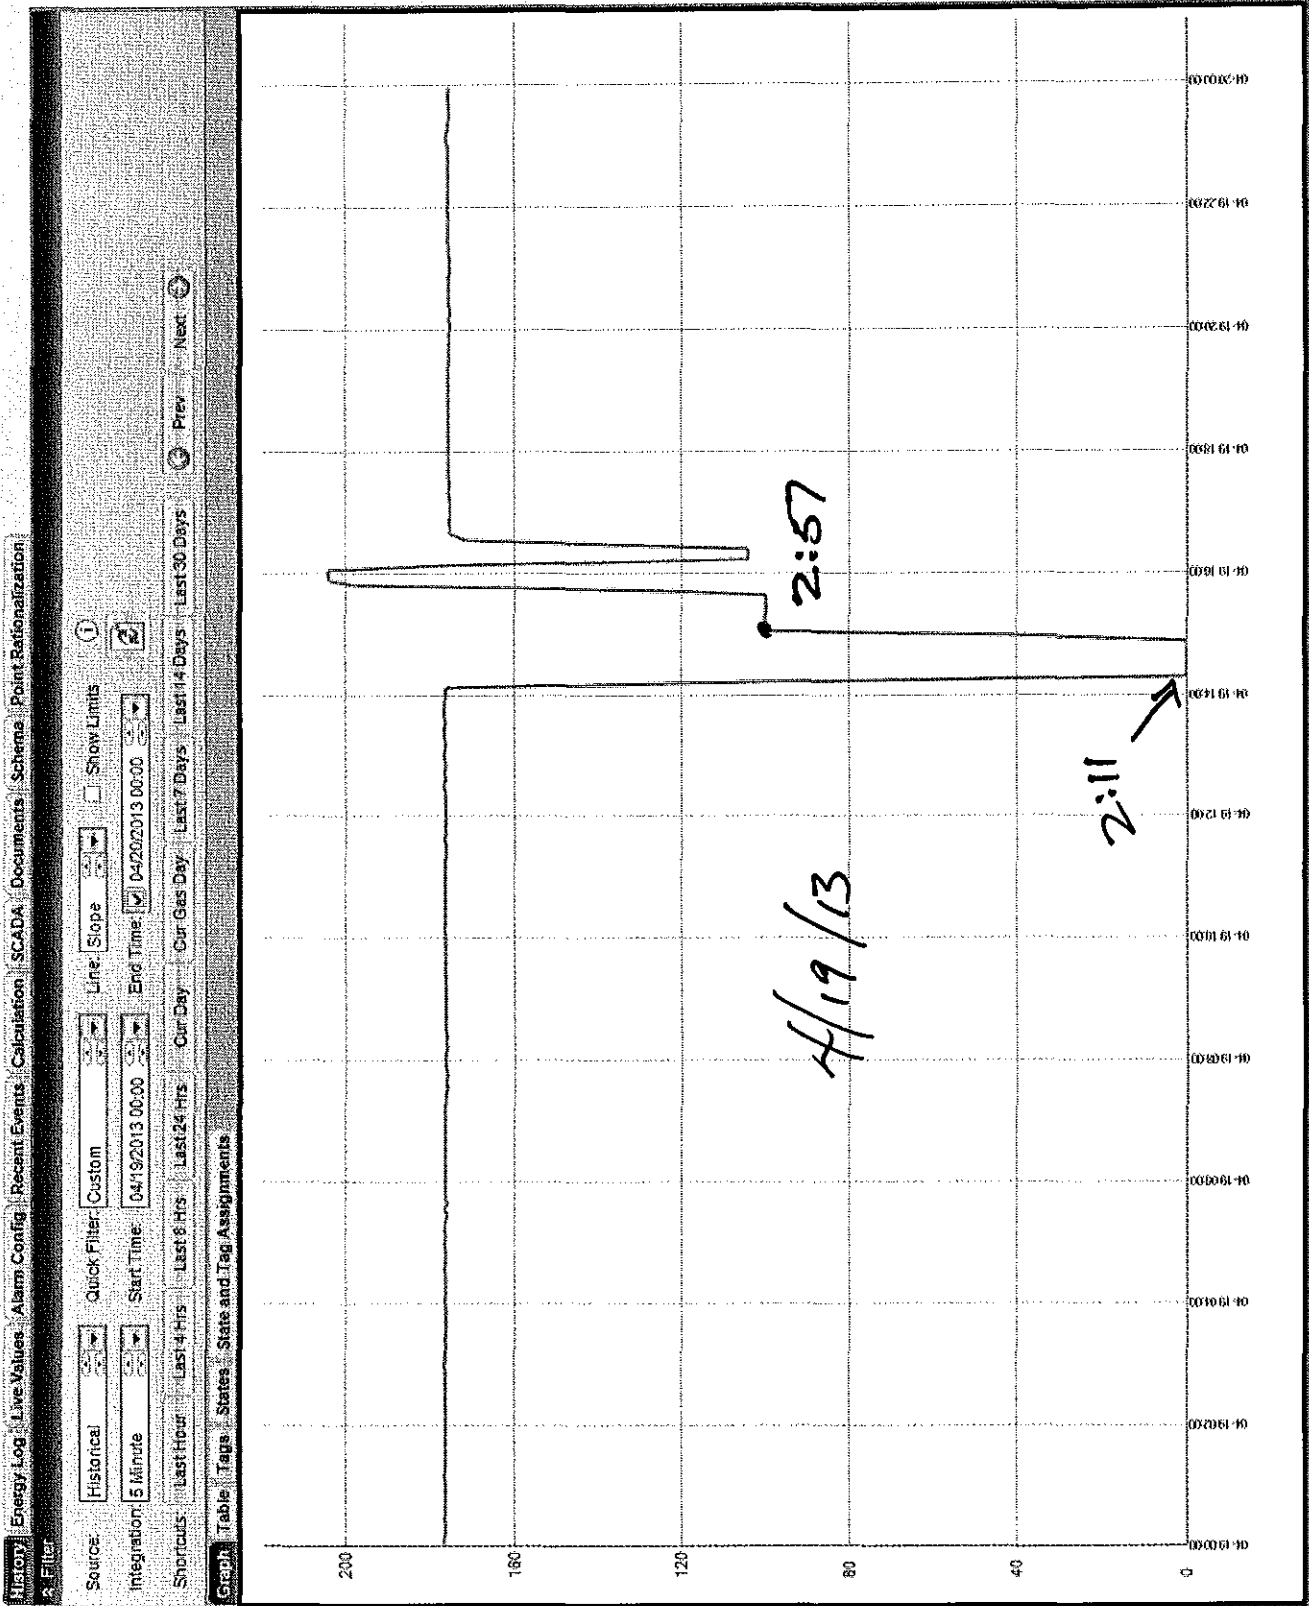
#2

NC Record Number: NCREG4776		Entity: Regional Generation	
Company - Level 1 - Level 2: UPP-Hoist Hydro			
Event Date:	04/19/2013	Discovery Date/Time:	4/19/13 14:12
Event Title:	Run of River deviation		
Event Details:	Plant trip due to power outage		
Immediate Action:	Notified hydro operator.		
Recommendations:	None		
Potential Causes/Contributors to incident	None		
Entered By Name:	Terrie S Taylor	Creation Date/Time:	4/19/13 14:24
Entered By Department:	Energy Supply & Control-GenCo	Status:	Closed
Reportable to External Agency:	yes	Basis for Reportability:	Part of A FERC Deviation letter submitted May 2nd to VS
Additional Followup Required:	no		
Category:	Regulatory	Type:	FERC Deviation
Sub Type:	Trans. Sys. (storm related)	Description:	
Causal Analysis Level:	Closed - No further action required	Causal Analysis Basis:	Event happened, unit tripped and came back on
Event Start:	4/19/2013 2:11 PM	Event End:	4/19/2013 2:57 PM

Event Duration (HH:MM):	00:46
Evaluator Name:		Evaluator Dept:	
Evaluation Accepted:		Acceptance Comments	L60
Eval Due Date:		Eval Completion Date:	
Approver Name:		Corrective Action Approver Name	
Analysis Description:			
Causes:			
Primary Causes:			
Does Eval Require Screening Committee Approval upon Completion			no
Evaluation Reviewed/Approved by Screening Committee

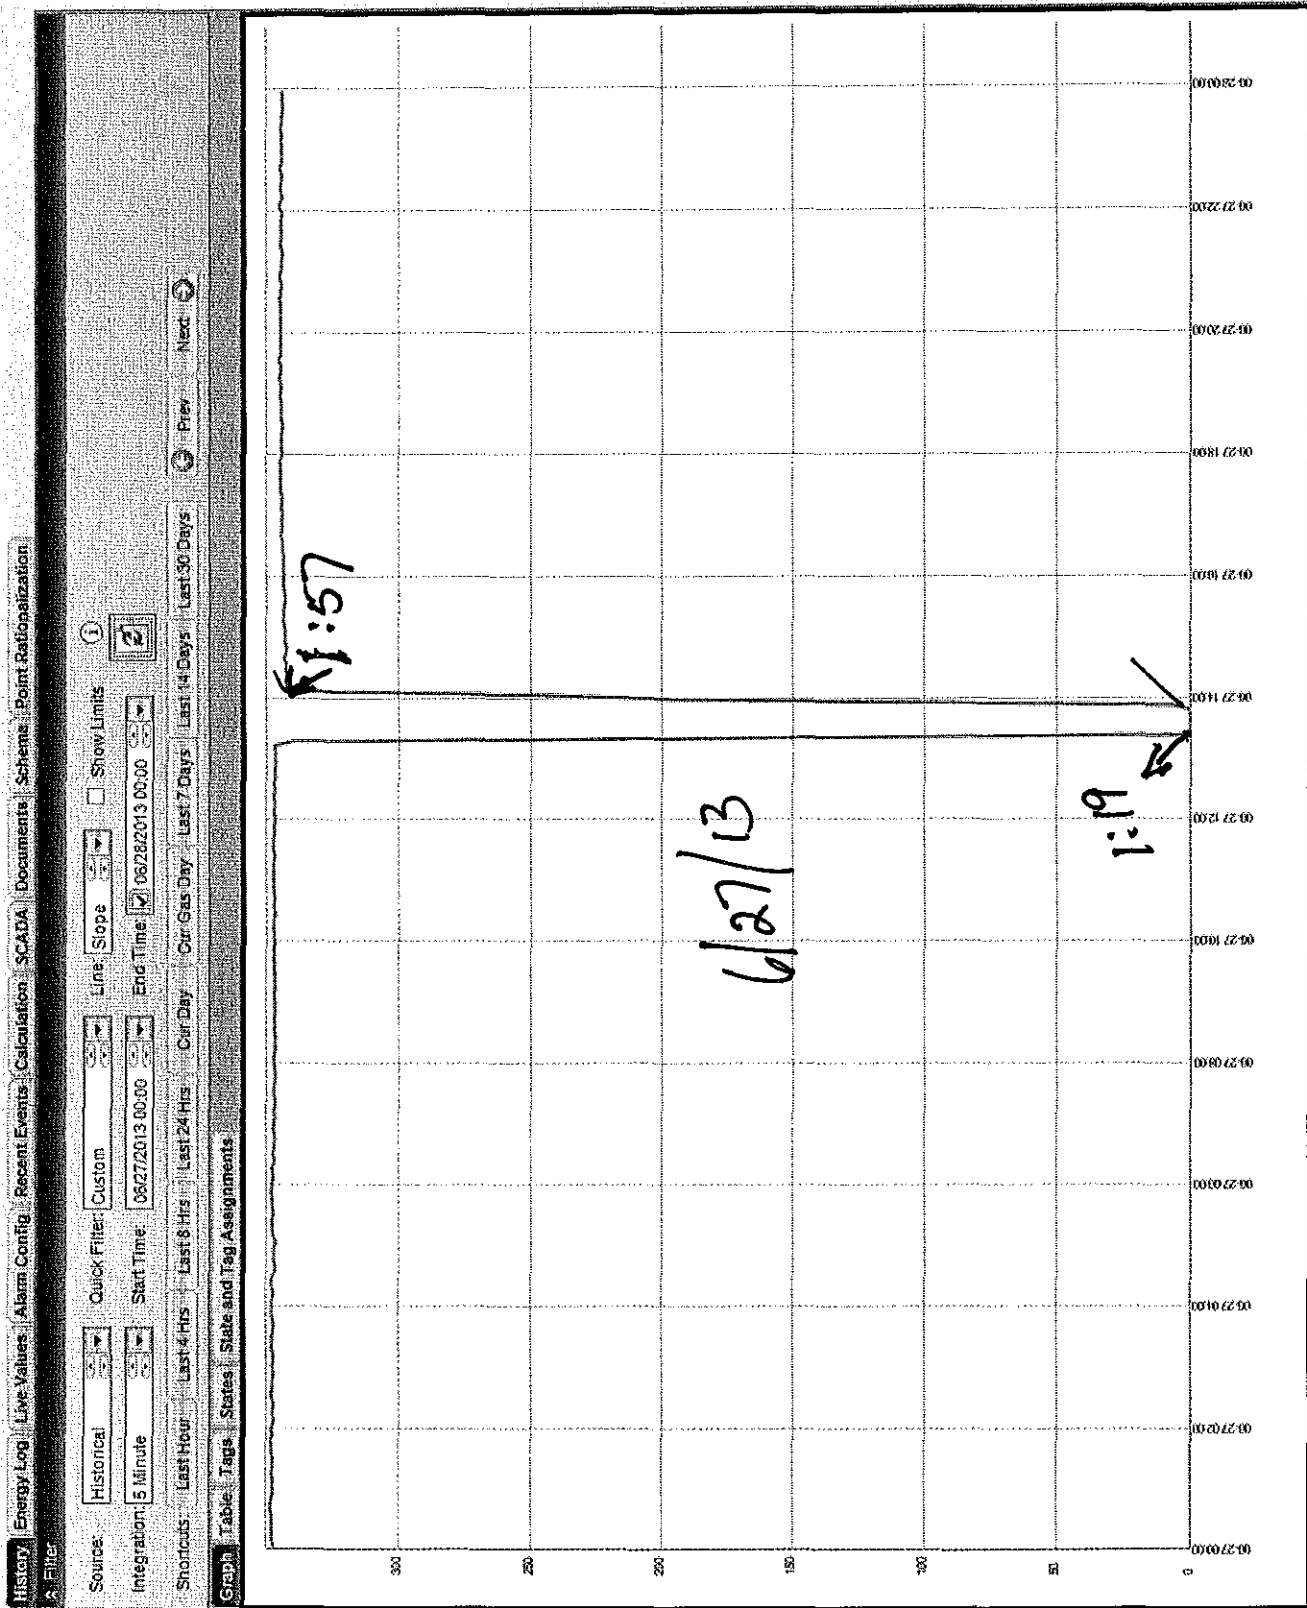
#4

NC Record Number: NCREG5013		Entity: Regional Generation	
Company - Level 1 - Level 2: UPP-Hoist Hydro			
Event Date:	06/27/2013	Discovery Date/Time:	6/27/13 13:19
Event Title:	Hoist generators trip		
Event Details:	Both units tripped. Had difficulty contacting operators due to intermittent phone problem. Contacted local operator at 13:33.		
Immediate Action:	Contacted operator.		
Recommendations:	n/a		
Potential Causes/Contributors to incident	weather		
Entered By Name:	Jonathon J Jenkins	Creation Date/Time:	6/27/13 14:49
Entered By Department:	Energy Supply & Control-GenCo	Status:	Closed
Reportable to External Agency:	yes	Basis for Reportability:	Letter to FERC - Draft to VES 7/15
Additional Followup Required:	yes		
Category:	Regulatory	Type:	FERC Deviation
Sub Type:	Trans. Sys. (storm related)	Description:	
Causal Analysis Level:	Closed - No further action required	Causal Analysis Basis:	Units put back on line

Event Start:	6/27/2013 1:19 PM	Event End:	6/27/2013 1:57 PM
		Event Duration (HH:MM):	00:38
Evaluator Name:		Evaluator Dept:	
Evaluation Accepted:		Acceptance Comments:	
Eval Due Date:		Eval Completion Date:	
Approver Name:		Corrective Action Approver Name:	
Analysis Description:			
Causes:			
Primary Causes:			
Does Eval Require Scening Committee Approval upon Completion			no
Evaluation Reviewed/Approved by Screening Committee
