Upper Peninsula Power Company

Assessment of the Recreation, Wildlife, Loon, and Aesthetic Resources of the

Au Train Impoundment Alger County, Michigan

Prepared by E·PRO Engineering & Environmental Consulting, LLC Augusta, Maine

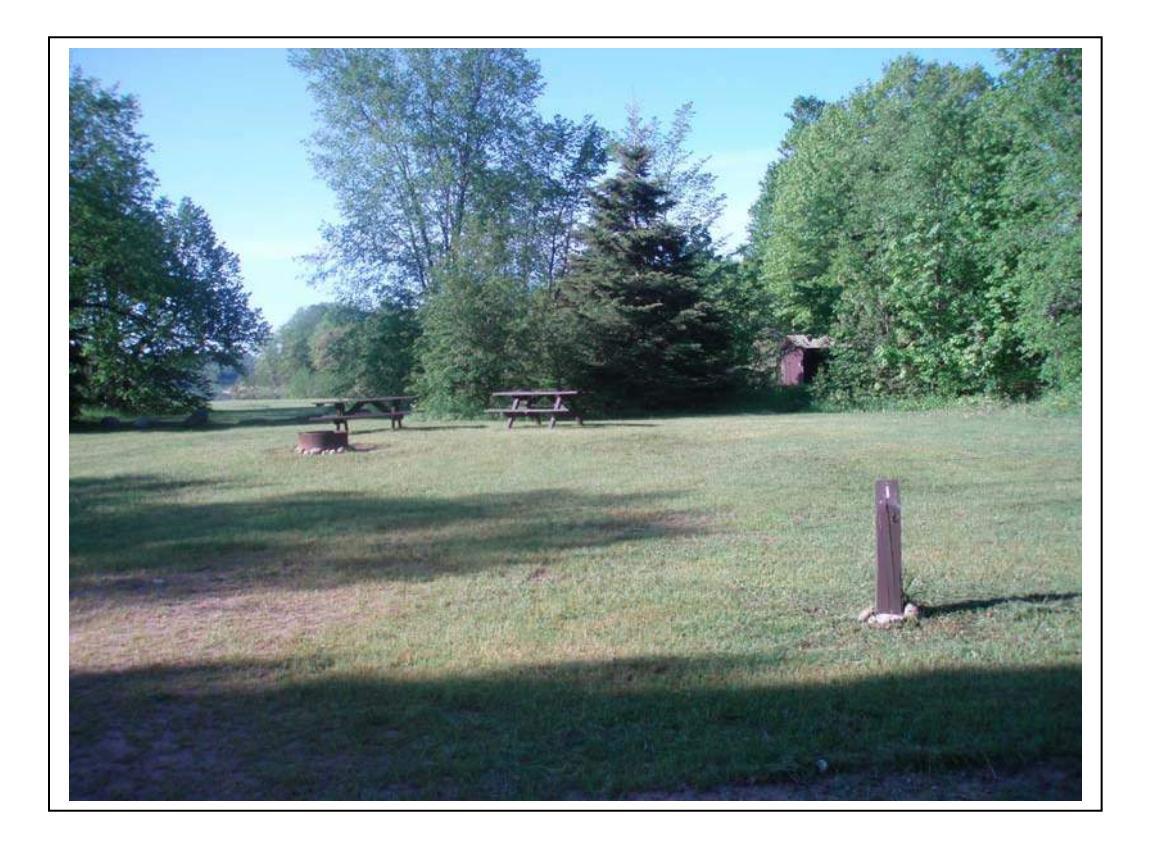
Figure 2-1: Site R-1 Campsite

Site R-1, Forest Lake Campground, is a formal campground and boat launching facility (See Figure 2-1). There is a boat ramp, a parking area for 15 vehicles with trailers and 15 passenger cars, and a courtesy dock available to the public for launching on the lake. There is also a 26-site campground with potable water. Each campsite has a picnic table and fire ring. There are two women's, two men's, and one unisex vault privies available around the campground and day use area.

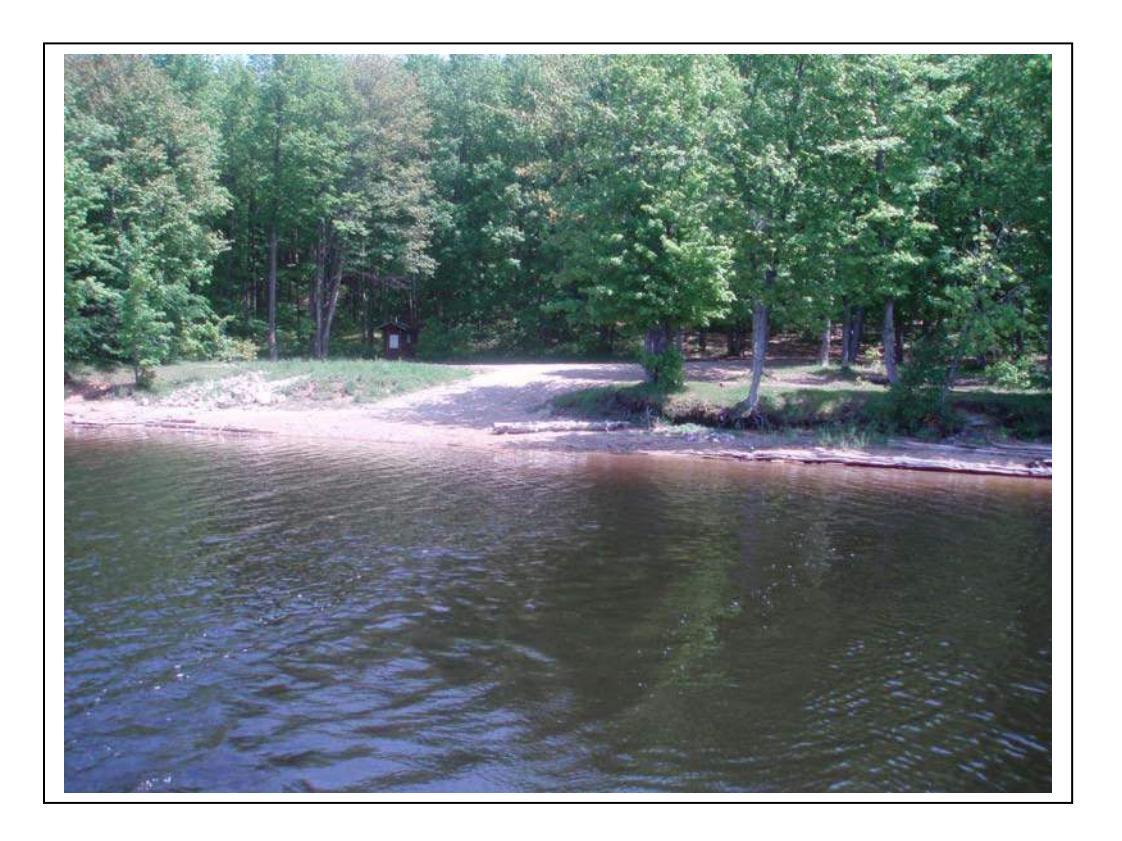
Figure 2-2: Site R-2 UPPCO Camping and Day Use Area

Site R-2 is a formal campground and boat launch area that is operated by UPPCO (See Figure 2-2). There is no formal parking area for the boat launch; however, there is enough space to park approximately three vehicles with trailers at the site. The boat launch is an unimproved gravel launch. There are seven campsites spread out along both sides of the boat launch that are accessible by vehicle.

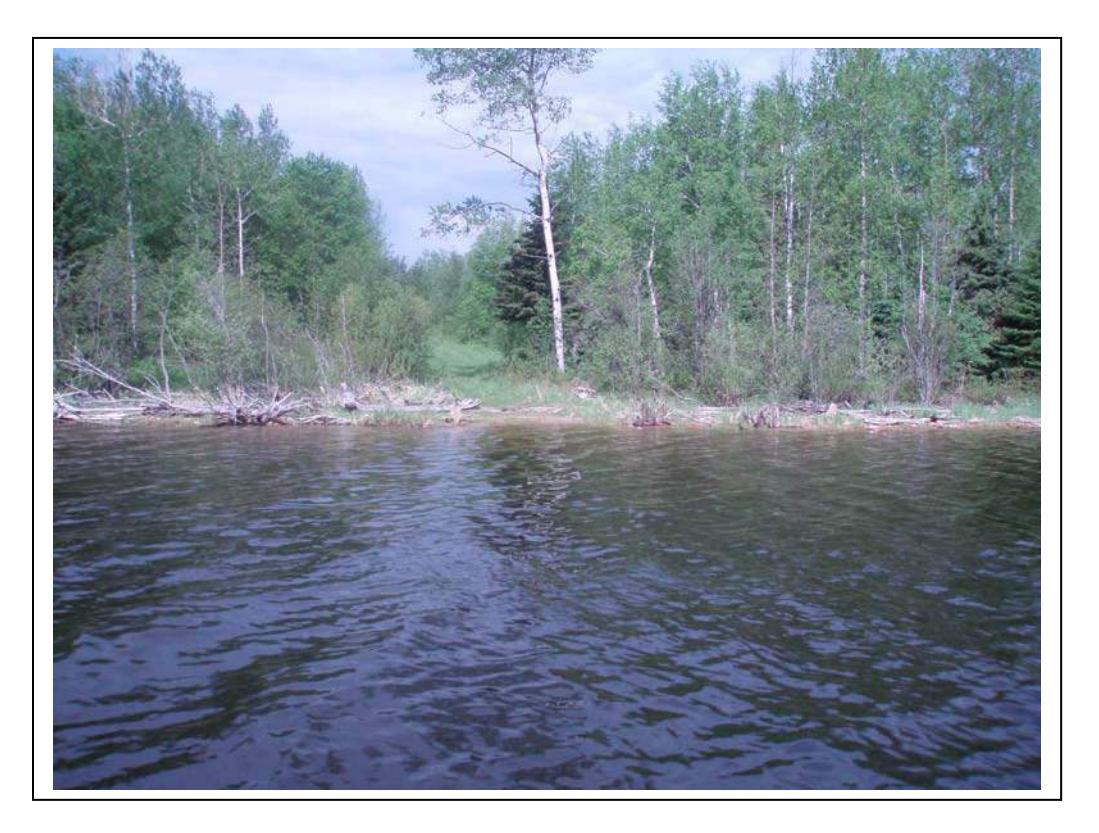
Figure 2-3: Informal Boat Launch Site R-3

Site R-3 is an informal boat ramp located at the end of a gated road (See Figure 2-3). The site is accessible by boat, as well as the dirt/grass road. There are no amenities at the site. While no erosion was observed, there was compaction evident at the site.

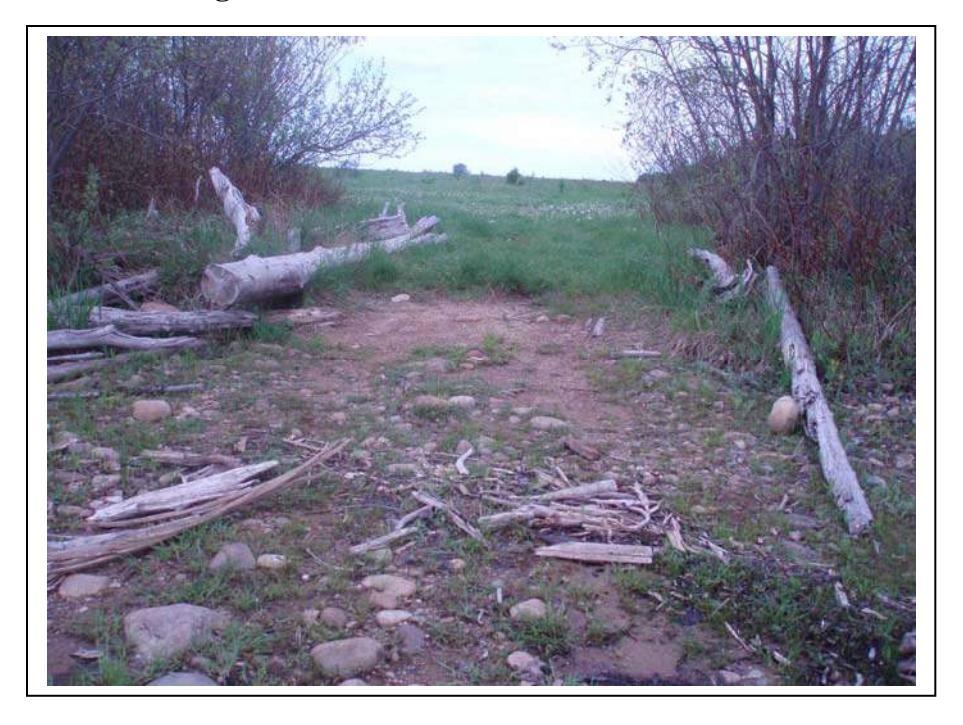
Figure 2-4: Site R-4 Informal Boat Launch

Site R-4 is an informal boat launching site that is accessible from the water or an unpaved single lane track (See Figure 2-4). There are no formal amenities. Compaction was noted while at the site. The site does not appear to receive much use.

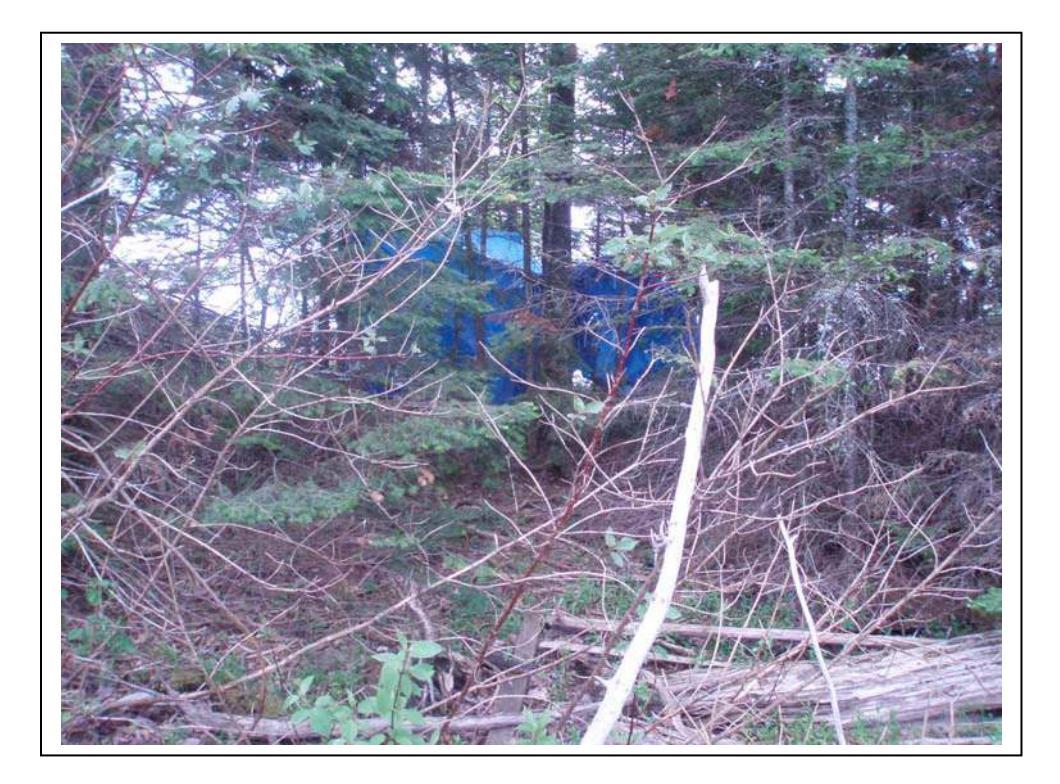
Figure 2-5: Informal Site R-5

Site R-5 is an informal campsite located on an island, and therefore is accessible from the water only (See Figure 2-5). There is an unauthorized fire ring at the site. The site does not appear to have received recent use, although there are the remnants of a shelter made out of a tarp on the island. There is erosion at the site.

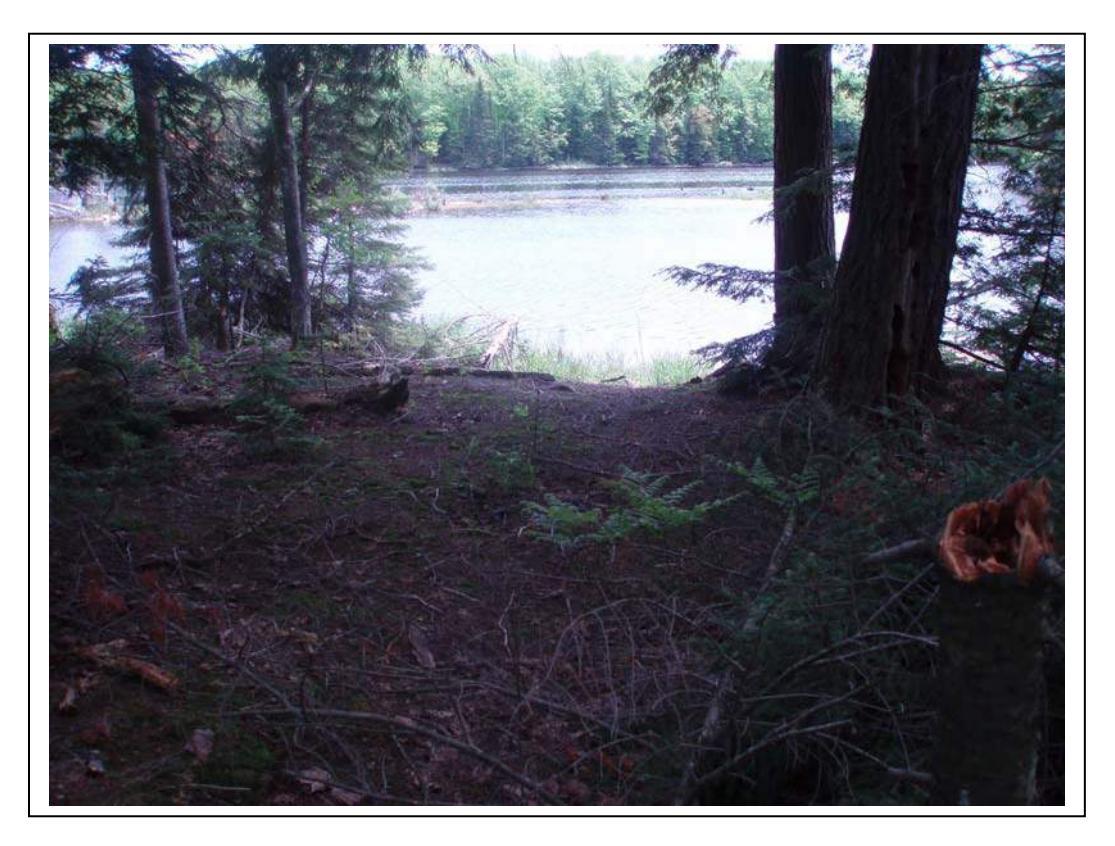
Site R-6 is an informal campsite and bank fishing area (See Figure 2-6). The site is also on an island and accessible from the water only. It appears that the site hasn't been used in a while. There is erosion on the shoreline.

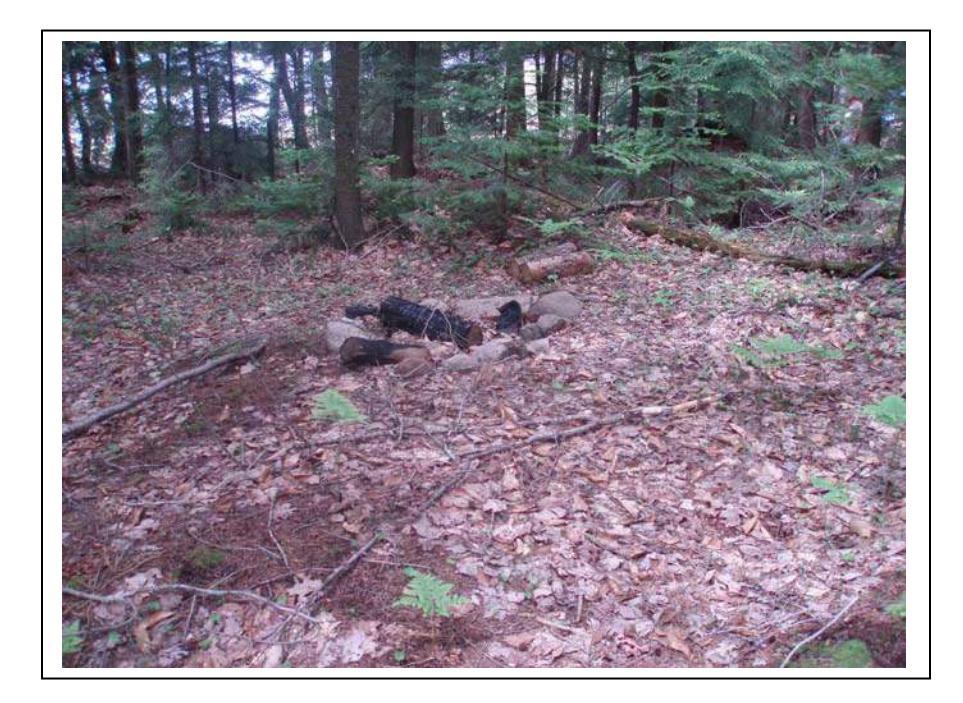
Figure 2-7: Site R-7 Fire Ring

Site R-7 is an informal campsite area (See Figure 2-7). Individuals have made unauthorized improvements to the site, which include a picnic table and fire ring. The site does not appear to have had recent use. There was erosion evident at the site. There is a make-shift shelter that has been constructed using a variety of available coniferous boughs.

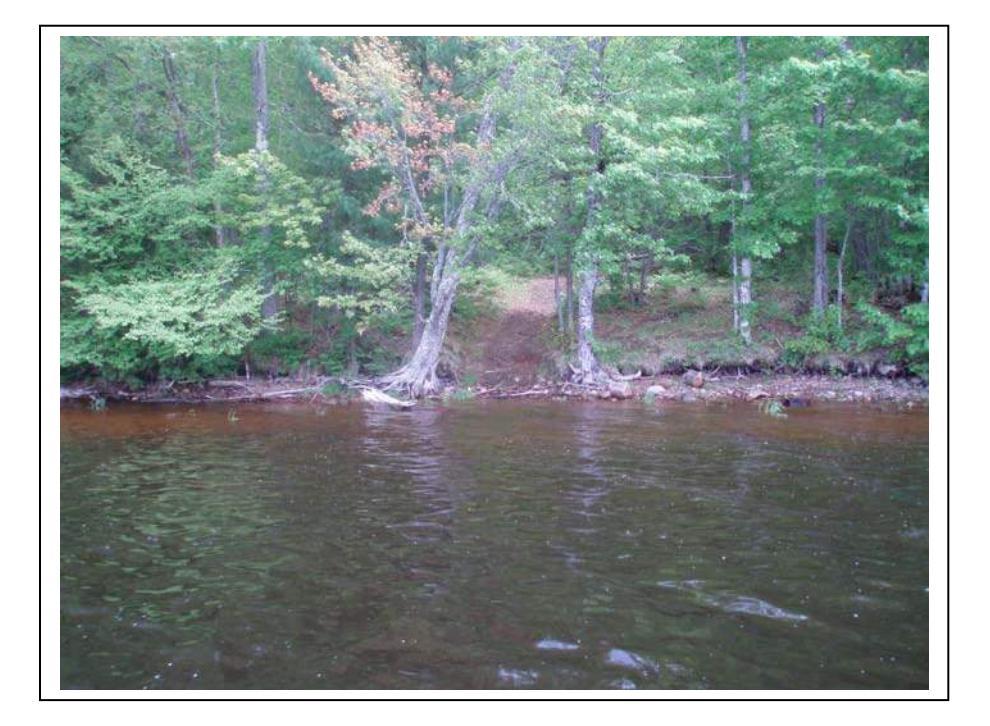
Figure 2-8: Site R-8

Site R-8 is an informal campsite accessible from the water or from a one-lane unpaved road (See Figure 2-8). The road proceeds beyond the Project boundary and accesses Route 94. There is an unauthorized fire ring on site. There was erosion noted along the shoreline. There is also compaction evident at the site. There is a tree blocking vehicle access to the camping area.

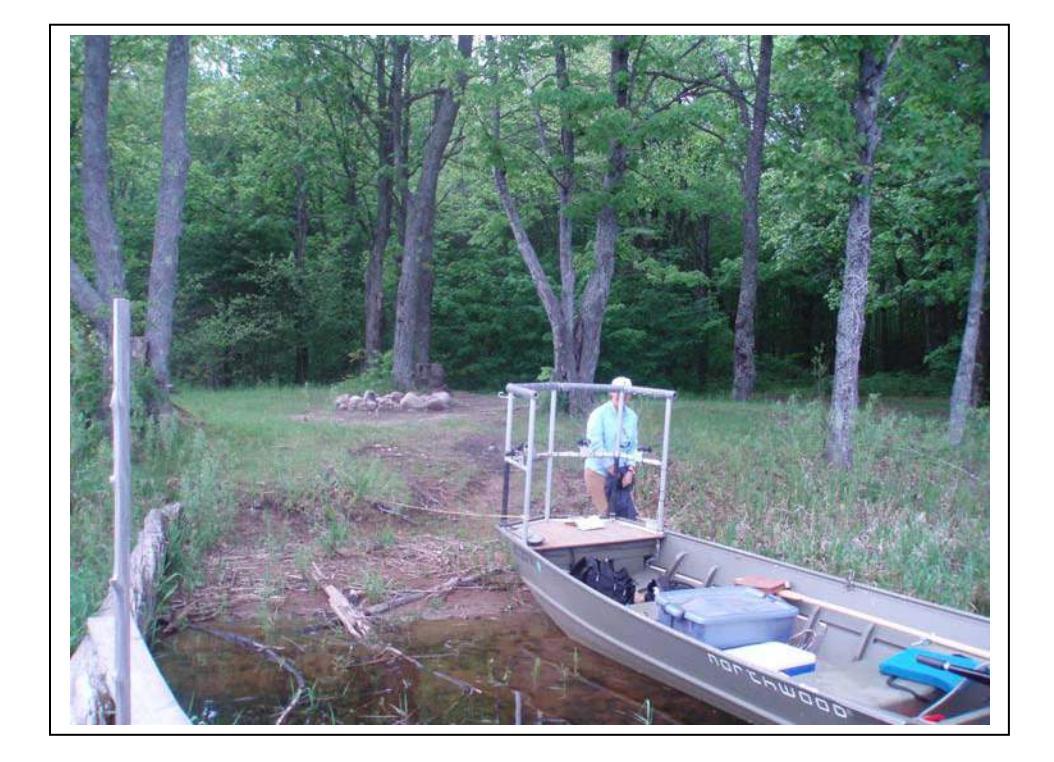
Site R-9 is an informal campsite that is accessible from the water or from a gated road (See Figure 2-9). There is a fire ring and dock at the site. Erosion was noted where individuals are accessing the site. There was also compaction noted. It appears that the site receives a considerable amount of use.

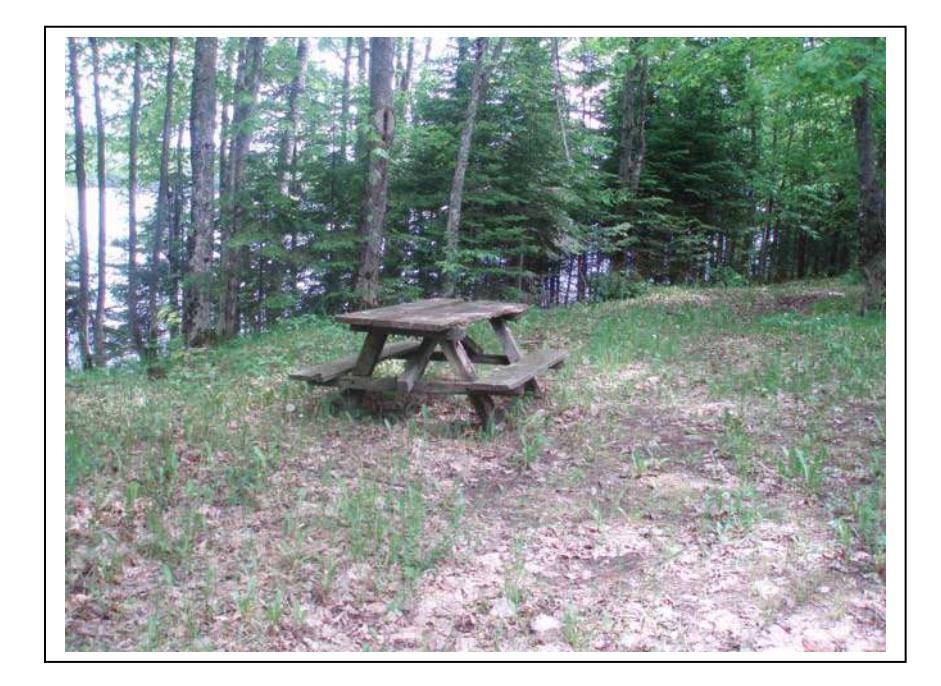
Figure 2-10: Site R-10 Picnic Table

Site R-10 is an informal campsite that is accessible from the water (See Figure 2-10). It appears that at one time the site was accessible via a one-lane unpaved road. There is a fire ring and picnic table at the site. There is erosion and compaction evident at the site. The site appears to receive some use during the summer season.

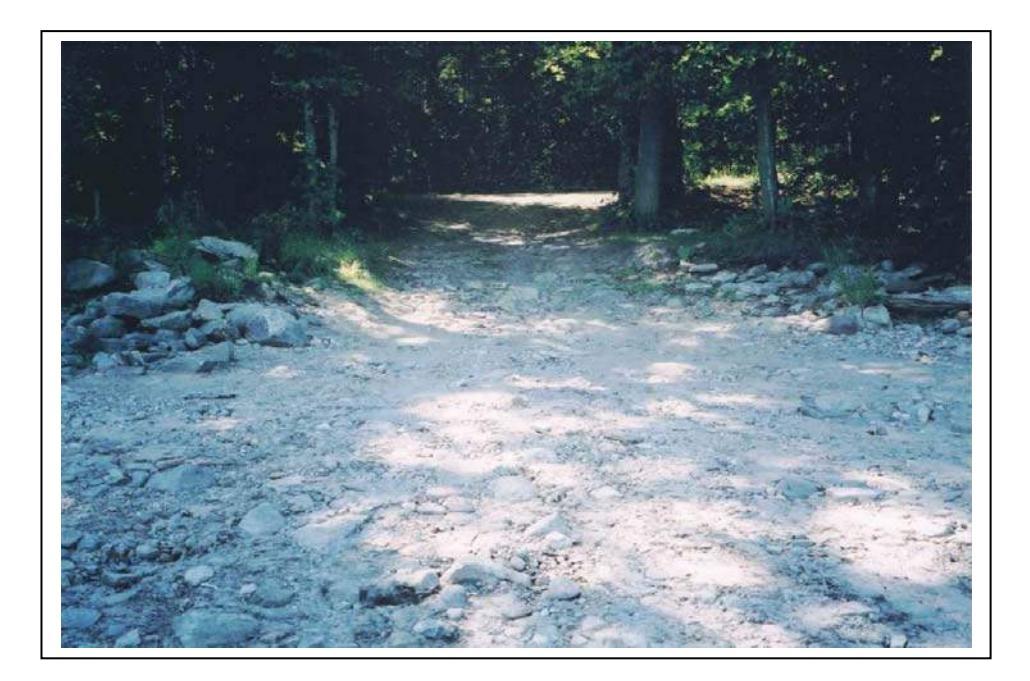
Figure 2-11: Site R-11 Launch from the water

Site R-11 is an informal boat launching area. There is room to park two vehicles with trailers. There is erosion evident at the site.

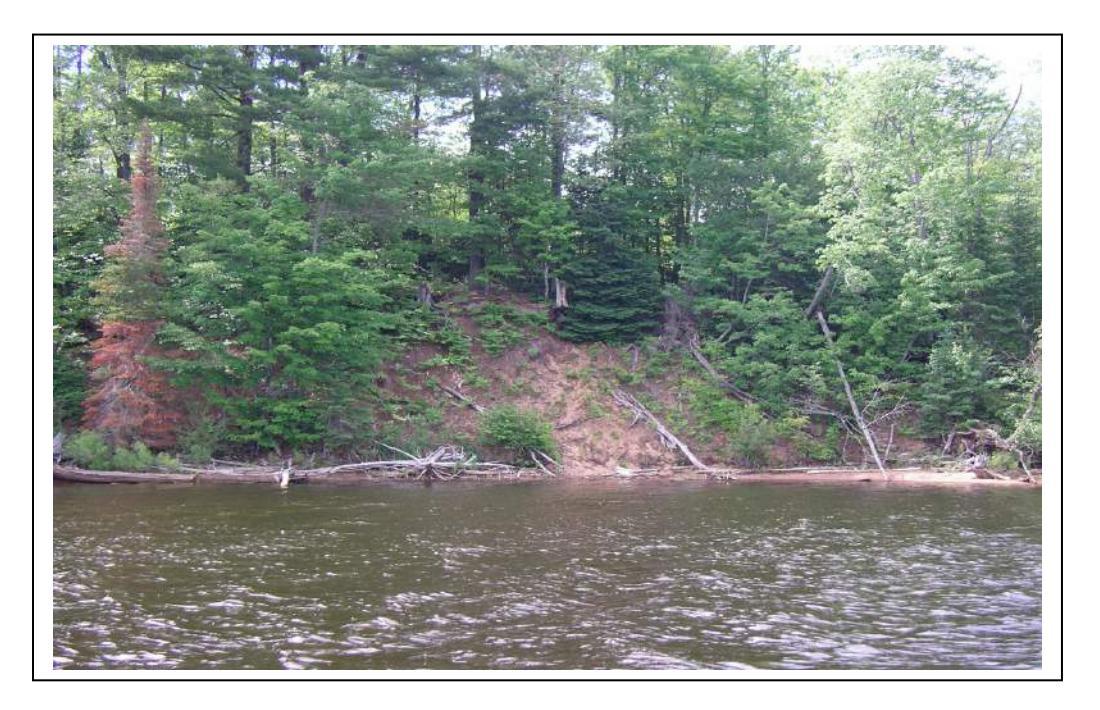
Figure 3-8: Small Erosion Area at Au Train

At Au Train, erosion features were found at three locations, two in the northwest corner of the impoundment (Map 3-1) and one in the southeast corner (Map 3-4). At the sites found at the northwest corner of the impoundment, the erosion was limited to steep banks composed primarily of sand and unconsolidated material. Although relatively tall and steep, the horizontal length of the eroding banks was relatively short (60 and 40 feet long). At the southeast corner of the impoundment, a small area of mass wasting was observed not far from the earthen dike. This area was about 30 feet long. Figure 3-8 shows one of the northwestern areas of erosion at Au Train.
